Analysis of the failure and remedial measures taken after the collapse of a historical bell

Salvador Ivorra^{a,*}, Benjamín Torres^a, Alfonso C. Cárcel^b

This paper describes the collapse analysis of the historical *El Jaume* bell, cast in 1429, one of the bells in the Cathedral of Valencia's *Micalet* bell tower (Spain). In 1992 the yoke was completely restored and given a new steel axis. The failure occurred when the bells were being rung on Christmas Day 2014, fortunately without any casualties. After several field visits to assess the damage and failure "in situ", a diagnosis was made of the causes of the failure. The diagnosis was the result of (1) a detailed visual inspection, (2) a metallographic and fractographic analysis of the fractured steel axis, (3) a fatigue damage analysis by finite element modelling software and (4) an estimation of the bell's remaining fatigue life cycle using Whöler S-N curves. In view of the results obtained it was concluded that the fatigue life cycle should have been reached between 300,000 and 400,000 cycles, while the failure occurred at 346,500 cycles. Although these elements are usually designed to not fail during its life, they can somet

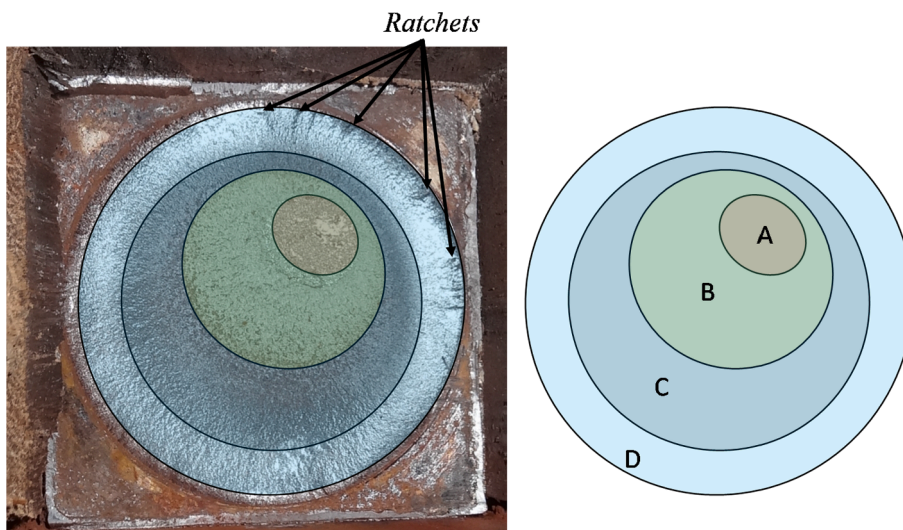
According to [30], this type of failure is typical of a shaft subjected to tension-compression stresses derived from positive-negative bending under low stresses – the bell goes through relatively few revolutions compared to an industrial machinery - but with severe stress concentrations (Fig. 4). Presence of ratchets is another characteristic feature of fatigue failures in rotating bending shafts (Fig. 3).

Fig. 3. Cross section of the different zones of the fractured axis.

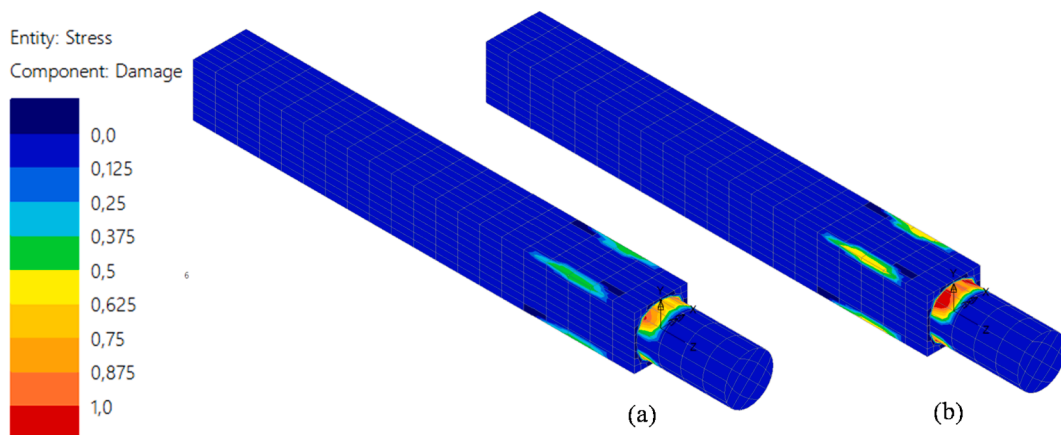
Fig. 9 shows a 3D plot of the damage distribution along the steel gudgeon for numbers of cycles corresponding to 300,000 (Fig. 3a) and 400,000 (Fig. 3b) cycles. In view of the results, it is observed that fatigue damage is concentrated and accumulated in the perimeter of circular section transition to square section. Around 300,000 cycles starts the fatigue damage, with damage values of $D = 1.06$ in certain small areas of the perimeter. For a value of 400,000 cycles, damage has spread along the perimeter, extending the damage zone and reaching most of the perimeter.

Fig. 9. Fatigue damage in steel axis. (a)- For 300,000 cycles. (b)- for 400,000 cycles.

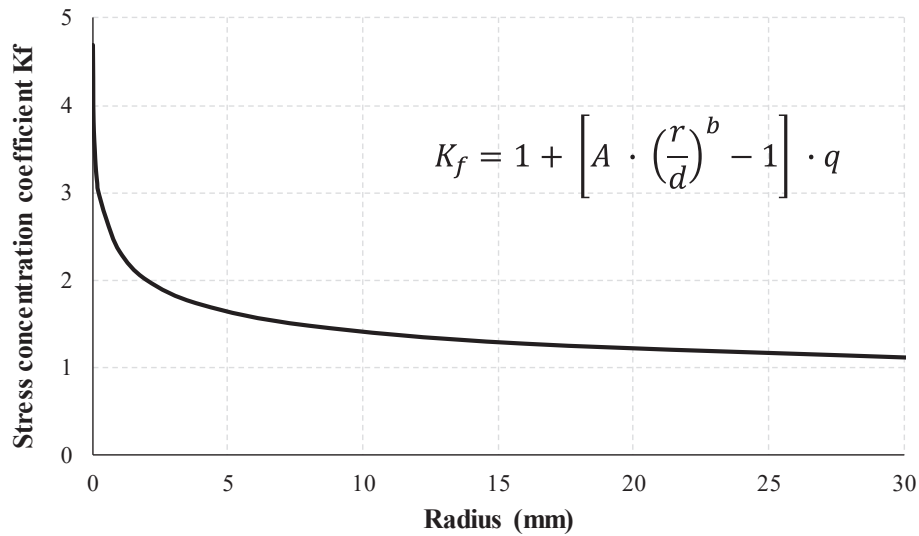
It can therefore be concluded that the fracture would not have happened had there been no transition between the gudgeon sections as there would have been no stress concentration effect (Fig. 14). As indicated in Fig. 13, this effect practically disappears after a 30 mm radius, although it could be deduced that the failure would not have occurred had there been a minimum transition radius of 2.5 mm (Fig. 14).

Fig. 13. Evolution of notch coefficient as a function transition radius.

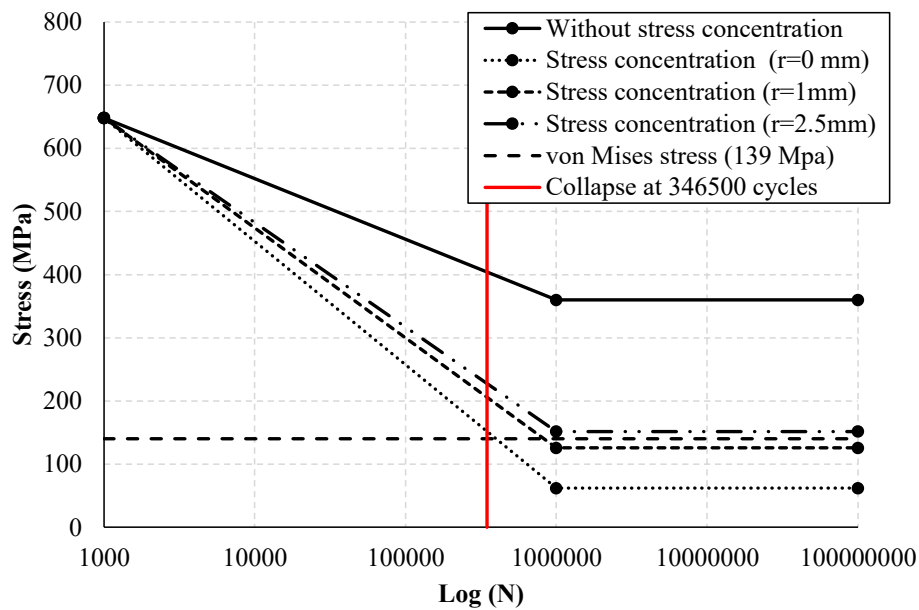
In view of these results, the fracture of the gudgeon due to the accumulated fatigue damage could have been foreseen in the bell's lifecycle. The main factor for this early fracture depended on the stress concentration effect caused by the abrupt size, transition between both sections. The most unfavourable situation of the break would have been after 355,000 cycles, considering a transition radius of 0 mm, i.e. a 90° joint. If it had been a 1 mm transition the break would have happened around 730,000 cycles. However, the visual inspection showed that there was no transition radius and that the two sections joined at 90°. Considering that the break occurred at 346,500 cycles (from the restoration in 1992 until the collapse in 2014) the failure scenario fits reasonably well with transition radius close to 0. One of the factors that probably could have reduced the bell's service life below the calculated 355,000 cycles and accelerated the fracture was the appearance of oxidation in the crack as shown in Fig. 3. The existence of some indentation marks at the transition zone, caused by the tools used when inserting the gudgeon into the bell wood counterweights, increased the stresses concentration effects and favoured the initiation of multiple cracks, as revealed by the observed ratchet marks in the surface fracture.

Fig. 14. S-N curves for the broken shaft considering different K_f coefficients.

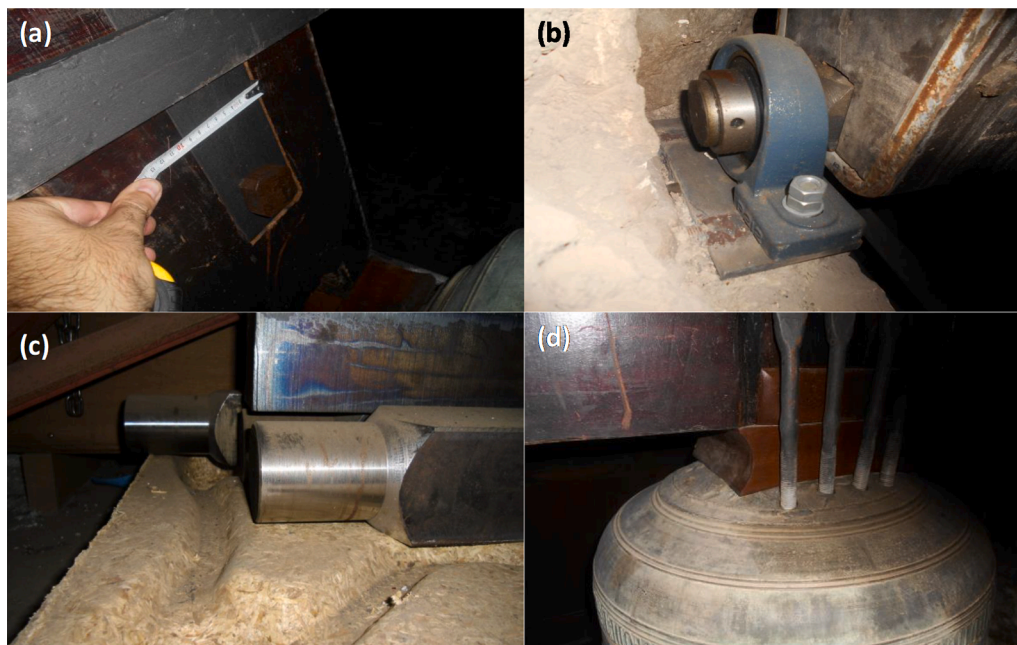
Fig. 15. Remedial measures to *El Jaume*.

This factor had the greatest impact on the gudgeon's fatigue strength deterioration. Fig. 15c shows the solution adopted to modify

the union between the circular and square sections to reduce the effect of the stress concentrations and so extend its life service by means of turning the shaft on a lathe. In addition to the increased shaft dimensions, this means the bell is now able to resist the fatigue stresses generated by the swinging.

The solutions applied to the canons broken bell to repair the broken *El Jaume* bell are shown in Fig. 15d. These consisted in removing the damaged canons, perforating 8 holes in the bell bronze and connecting them to the upper counterweight by 20 mm diameter circular bars. These were anchored to the interior of the bell by nuts and washers, reinforced the number of connections between the bronze and wood counterweight and guaranteed the safety against possible failures during swinging.
