SEISMIC AND ENERGY RENOVATION FOR SUSTAINABLE CITIES CONFERENCE PROCEEDINGS

The Collapse of the Tower of Valladolid Cathedral and its Controversial Relationship with the 1755 Lisbon Earthquake

Angelo Salemi^a, José Ignacio Sánchez Rivera^{b*}, Attilio Mondello^a,
Juan Luis Sáiz Virumbrales^c

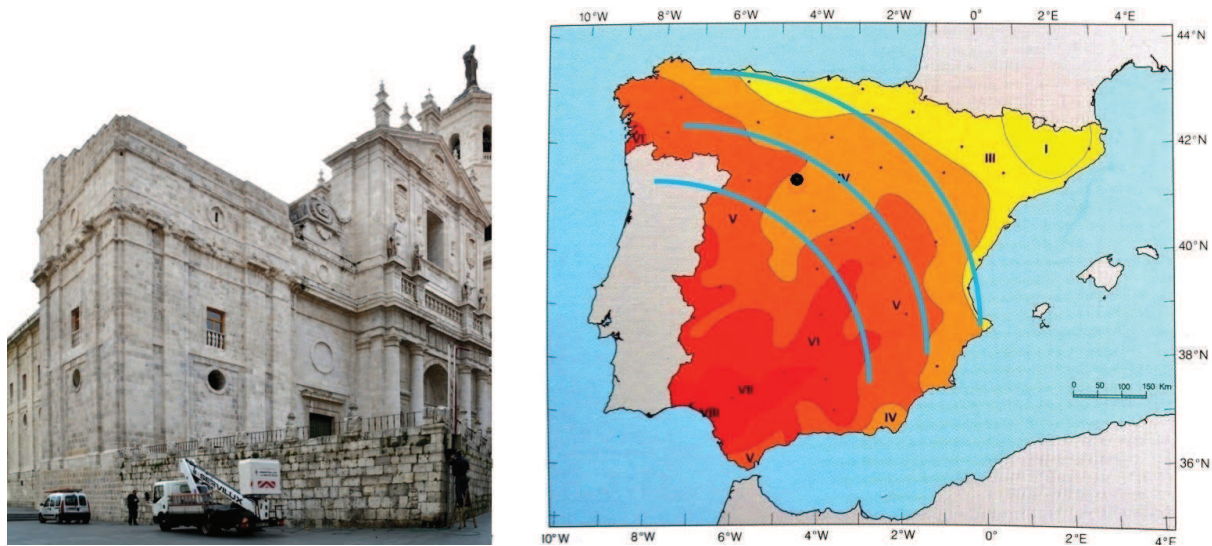
Fig. 1. (a) On the left: The remains of the fallen-down tower of the Cathedral of Valladolid at its present state. (b) On the right: Map of Peninsular Spain with the isoseismic lines of the 1755 Lisbon Earthquake. Valladolid's position is denoted by the heavy black point.

On the June 5th, the military engineers produced a new report. This time they noticed four ancient fissures, concealed with lime, on the north face of the tower, just below the arches of the third body and close to the angles, so now they thought of a foundation seat, but without major consideration. For them, the collapse of the southeast corner was "*very light*" and the remains of the tower were in no danger of immediate ruin. Ten days later, the architects made another report in which they mentioned the great collapse of the tower walls and sentenced the demolition of everything except the first body and the base of the second. The Chapter was in a terrible economic situation, after the Mendizábal's Confiscations, reason why they requested the City council's help for the demolition; after several eventualities, one prisoner, Francisco González, offered the City council to dismantle the high parts of the tower so that his sentence would be reduced. His offer was accepted; Gonzalez, at the head of a group of inmates, dismantled the tower during the following months, except for its lower body and a small part of the second, practically what is preserved today [38]. The brick vault of the tower lower chapel was rebuilt and the tower remains were covered with a simple roof (fig. 1a).

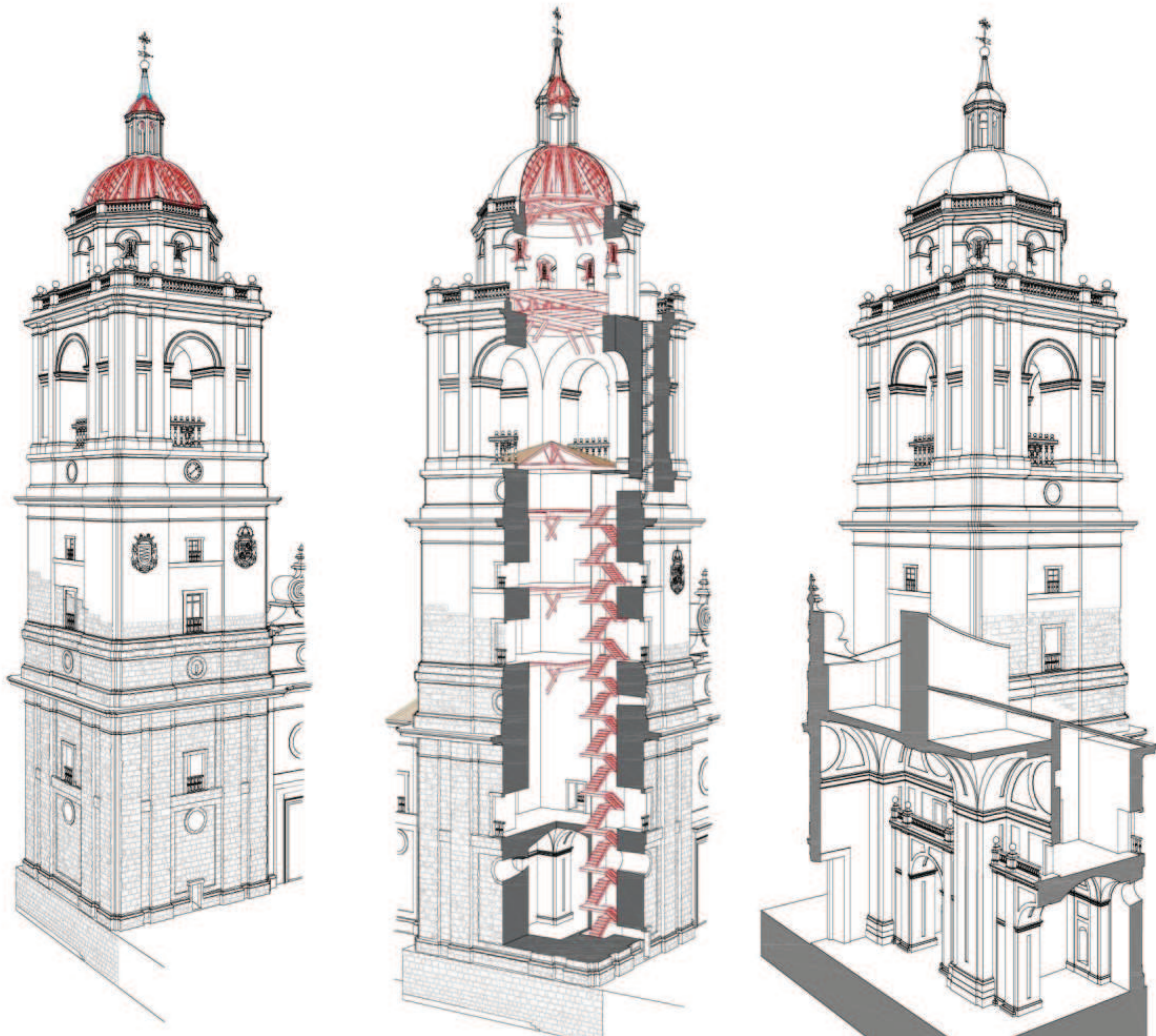
Fig. 2. Restitution of the tower. On the left, view from the Southwest; the dome shows its internal wooden structure, without its slate pieces surface. On the centre, section of the tower displaying its internal layout and staircases. On the right, view from the Northeast, showing the relation of the tower with the aisle and side chapels. Drawings by the authors.

It does not seem that the chapter took any decision at that time, perhaps due to economic problems. However, the Canon in charge of the building warned the chapter on February 19th, 1746 that a decision had to be made, since the supporting frame of the ruined dome was about to break down. The chapter resolved, in view of the reports, that Antonio Pontones “*is to demolish the dome, and make a wooden spire covered in slate as beautiful and graceful as possible*”. Pontones carried out the spire as the chapter had commanded, since the expenses of the work are recorded in the chapter's accounts [28]. For the external shape, Pontones seems to have taken as reference the demolished dome, with its rather depressed form and its octagon shape. Seeing the preserved detailed invoices of the woods used, we have thought that its structure would be linked to examples of “*encamonada*” dome (false dome with a wooden frame) as established by Fr. Lorenzo de San Nicolás on his book [29]; In this way we have made our drawings, showing such wooden structure (fig. 2).

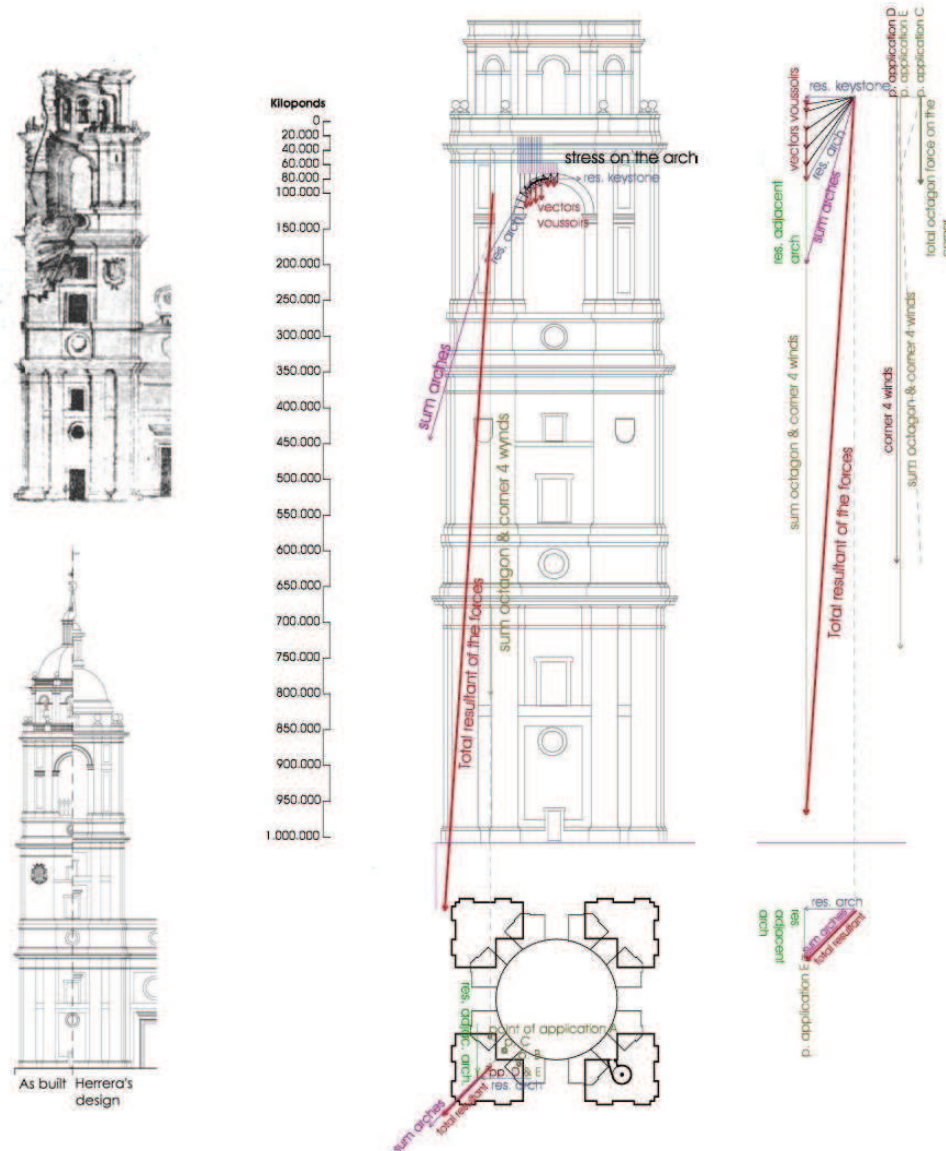
Juan de Herrera's designs for the tower were altered during its construction, we rather think for functional reasons (fig. 3b): the tower had to house the clock and, in its upper part, the bells. Herrera had not made space for the dial, which was done by hypertrophying the podium of the third body of the tower. Perhaps to maintain the proportions in some way, the double pilasters of the second body were transformed into wide simple pilasters, to place the Royal and City Shields. The entablature that finished the third body, acquired greater heaviness following Baroque fashion, diminishing the great arches underneath. On the other hand, Herrera probably had thought to place the bells in a wooden structure inside the third body, which with its large openings would have allowed the expansion of sound; notwithstanding, the Spanish Baroque tendency demanded great turning around bells. So, to arrange them this way, an octagon body was added, with arches for the bells, replacing the dome's low drum that, apparently, Herrera had thought to top off his main towers.

Fig. 3. (a) Top left: The tower just after its 1841 collapse (contemporary drawing by I. Dominguez); (b) Bottom left: comparison between the built tower and its design by Juan de Herrera; (c) Right: Static calculation of the fallen down tower corner. Note the total resultant of the forces (on heavy red) fitted to the angle on the tower’s lower section. Drawings by the authors.

To start and have a good tool for this mission, we have made a structural static graph calculation of the collapsed corner of the tower (fig. 3c). First, let us examine the 1841's fall with its aid. The documentation provided tells us that the tower fall produced two consecutive noises, the second being greater. In our opinion, this occurred because an external section of the wall collapsed first, in a sector in which, as we have seen, the wall-facing was giving problems for decades (remember that in 1788 it is mentioned as an old damage); in the structural calculation we provide (fig. 3c), it is observed that the resultant of the forces of the tower crossed near the edge of the wall in the two lower bodies; therefore, when an external part of the wall collapsed, the result of the forces had no wall to pass through and as a consequence the entire corner of the tower fell, causing the second, louder noise.

More difficult is to clarify why the wall broke down into leaves and its outside fell. We can dismiss the foundation seat because we conserve the first body of the tower and there we have not observed any damage of such consideration that could support this hypothesis, although the River Esgueva ran next to the tower. On the other hand, it has already been said that both the architects and the military engineers, who judged the construction when the tower collapsed, criticized its poor quality and its lack of unions. The problem could come from the fact that the lime from the wall-core retracted in the years thereafter its construction, leaving the weight of the tower in the two-thin wall-facings (interior and exterior), to make them buckle; we also discard this since the repair of the facing carried out in 1806 by partially disassembling it would have been difficult and could have easily led to the fall of the tower. Therefore, we are inclined to think that the facing would have rather been pushed by one of the leaves into which the wall would have been divided by discontinuities in its bosom. These discontinuities, product of its bad construction, would have been aggravated by the leaks that we know the tower had during practically all its time: when the water drained from the terrace between the third and fourth bodies (something of what J. de la Calle had warned in his report in 1740) it would drag the lime, producing new seats and, upon freezing, it would make bigger discontinuities [39]; reinforces this hypothesis that the broken corner of the tower was the most hit by rainfall, taken into account the prevailing winds in Valladolid.

On the other hand, both 1841 engineers' reports and previous ones mentioned the vertical cracks that the tower had in its corners, just below the body of the four winds, whose corners carried parts of the lower walls, while those under the arches were unloaded; this would cause differential stresses in the walls that would cause such vertical cracks (years ago, one of these was still visible on the corner of the lower body, as show 1930s. photographs). These cracks, together with the internal discontinuities, could have freed the outer part of the corner from the rest of the walls [40], pushed outwards with the different filtrations produced by the rainfall; it is interesting to note that the collapse occurred just after a storm.

Nowadays, these problems would have been solved by means of sewing and limewater injections in the walls of the tower, a technique that naturally did not exist in 18th Century; for that reason, the intervention of Ventura Rodríguez in 1761 reinforcing the tower could had been a system to avoid the disintegration and separation of the walls of the tower; the loss of the report presented by this architect prevents us from knowing the true reasons for his actions. It has already been seen, in the reports of the 1740s, that most of the consulted architects doubted the tower's strength, even before the Lisbon Earthquake: some already spoke of cracks and unanimously claimed the need to remove weight from the construction; indeed, our study of graphical statics yields the result of how tight was the static of the element, with the resultant-force about to leave its walls in the lower part of the tower; this allows us to see that the problems were prior to the earthquake and that this was not the triggering cause, although it may have added to the problem; besides, we have already mentioned that in the region, the intensity of this earthquake was lower than expected given the geographical situation and that the only significant damage in the area seems to have been the tower of the Collegiate-Church of Ampudia (Province of Palencia), that has a graceful crown with pieces presenting little stability.
