Analysis of the failure and remedial measures taken after the collapse of a historical bell

Salvador Ivorra^{a,*}, Benjamín Torres^a, Alfonso C. Cárcel^b

This paper describes the collapse analysis of the historical *El Jaume* bell, cast in 1429, one of the bells in the Cathedral of Valencia's *Micalet* bell tower (Spain). In 1992 the yoke was completely restored and given a new steel axis. The failure occurred when the bells were being rung on Christmas Day 2014, fortunately without any casualties. After several field visits to assess the damage and failure "in situ", a diagnosis was made of the causes of the failure. The diagnosis was the result of (1) a detailed visual inspection, (2) a metallographic and fractographic analysis of the fractured steel axis, (3) a fatigue damage analysis by finite element modelling software and (4) an estimation of the bell's remaining fatigue life cycle using Whöler S-N curves. In view of the results obtained it was concluded that the fatigue life cycle should have been reached between 300,000 and 400,000 cycles, while the failure occurred at 346,500 cycles. Although these elements are usually designed to not fail during its life, they can somet

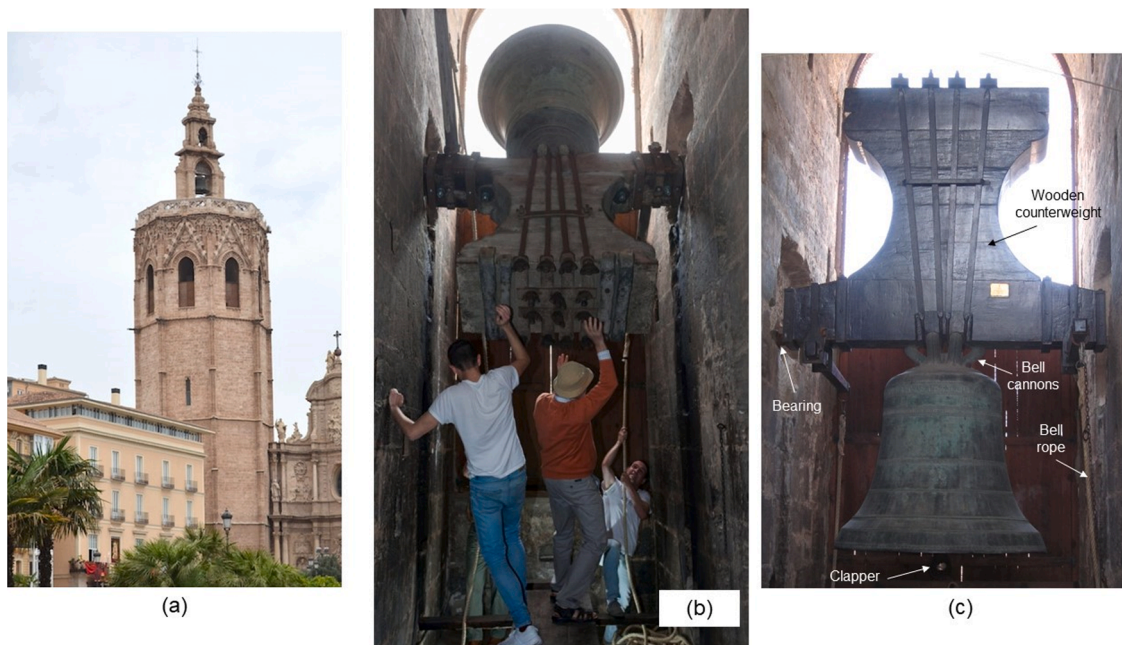
Fig. 1. (a)- *El Micalet* bell tower. (b)- Bell ringers ringing the bell manually (c)- *El Jaume* bell.

On Christmas Day 2014 *El Jaume* bell (Fig. 1c) suddenly collapsed when being rung manually. Due to the bell's famous reputation the news was reported in the national and international media.

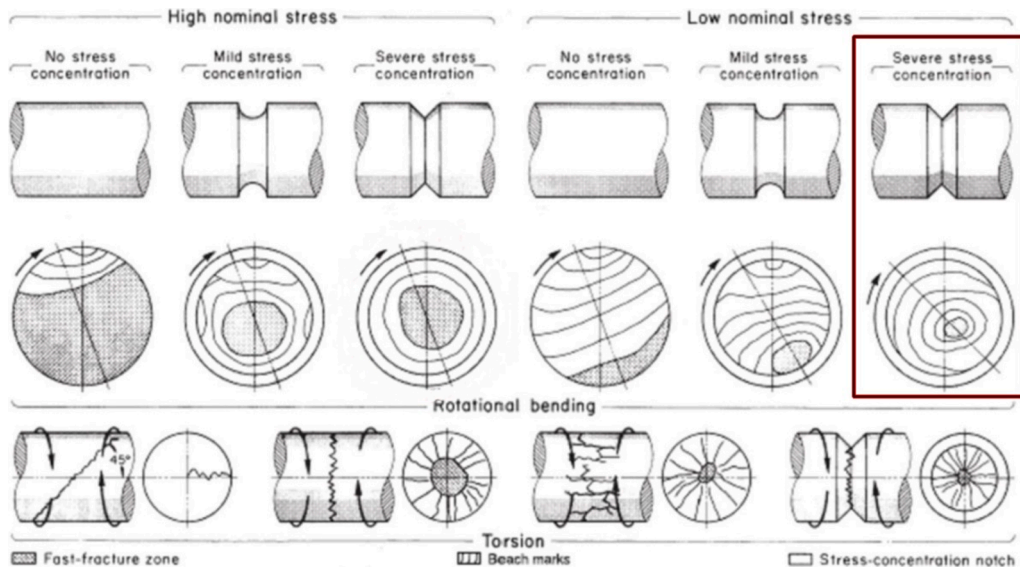
According to [30], this type of failure is typical of a shaft subjected to tension-compression stresses derived from positive-negative bending under low stresses – the bell goes through relatively few revolutions compared to an industrial machinery - but with severe stress concentrations (Fig. 4). Presence of ratchets is another characteristic feature of fatigue failures in rotating bending shafts (Fig. 3).

Fig. 4. Schematics of fatigue fracture surfaces from ASM Metals Handbook [30]. Obtained from [31].

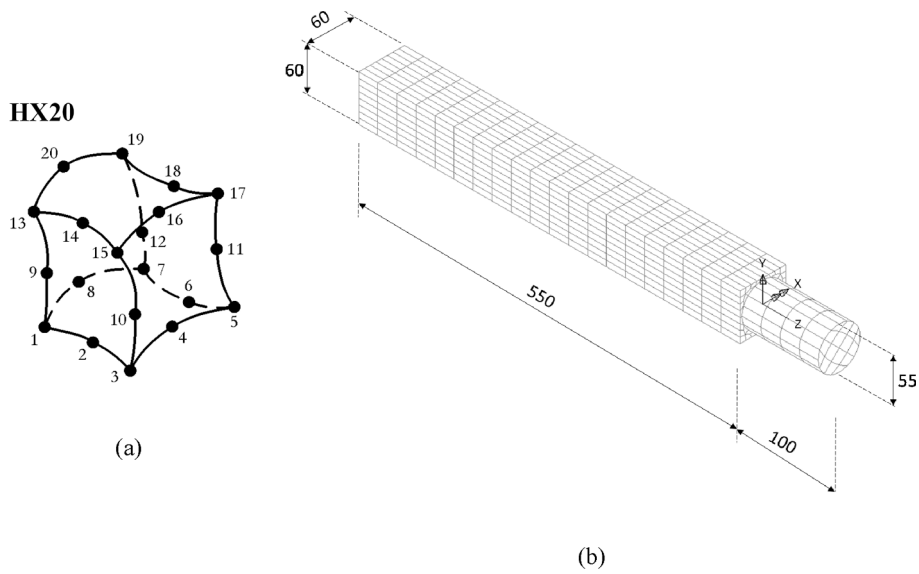
The numerical study was carried out with Lusas software [39]. Steel gudgeon was modelled with hexahedra 3D HX20 solid elements (Fig. 7a). Each of these elements had 20 nodes, each node with three degrees of freedom (Translation along X, Y, Z). For material properties, a conventional steel has been used with a Young's Modulus of 210000 MPa, a Poisson's ratio of 0.3 and a mass density of $7.8 \cdot 10^{-9}$ N/mm³. All the model elements had linear elastic behaviour. The model (Fig. 7b) has a total number of 1344 finite elements.

Fig. 7. (a)- Hexaetra 3D HX20 element. (b)- Finite element model of the steel axis (mm).
